AQUATIC CONSULTING & TESTING, INC.

Dobson Ranch HOA
2719 South Reyes
Mesa, Arizona 85202

May 2025 Lake Report

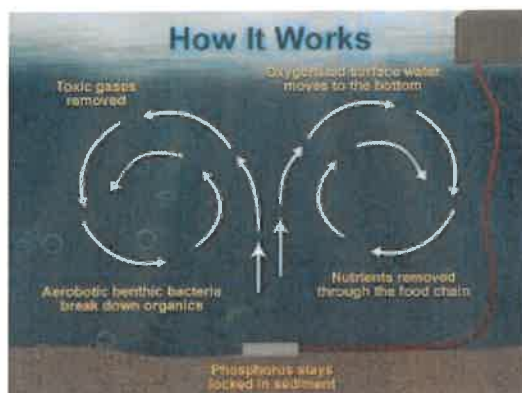
Aeration systems are designed to circulate and distribute oxygen vertically in the water column. Circulation is necessary for two primary purposes: (1) to deliver oxygen to the deeper waters for fish survival and (2) to maintain an aerobic environment throughout the lake to prevent the release and distribution of phosphates, ammonia, and sulfide from the anaerobic sediment.

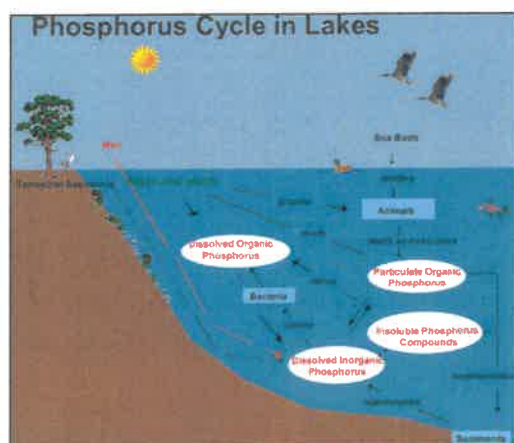
Algae are plants and require nitrogen and phosphorus for growth. In the desert southwest, large growths of planktonic algae typically form in the summer when total phosphorus concentrations are above 0.030 mg/L. Nitrogen values usually need to be at least 10 times that of phosphorus and in a soluble, usable (nitrate or ammonia) form to stimulate algae growth. Phosphorus and nitrogen cycles in the aquatic environment are illustrated below.

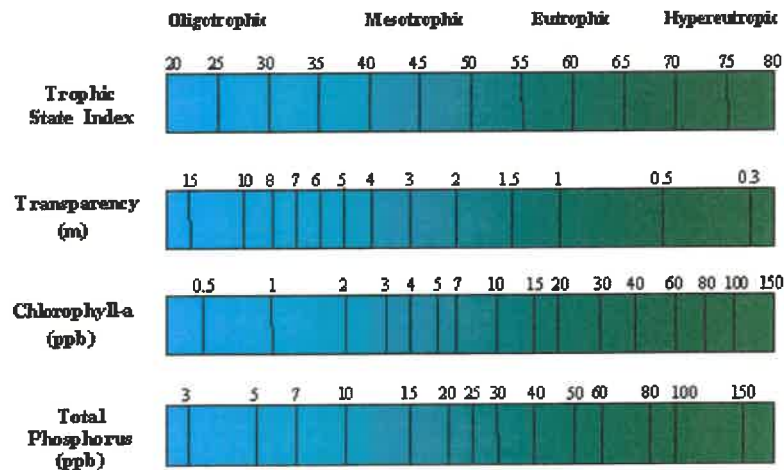
The Carlson Trophic Status Index (TSI) is a series of calculations that attempt to put a numerical value on water quality. The more algae and greener a lake is, the more nutrients a lake has, and the less transparent the water becomes, the higher the trophic status and the greater the TSI value. Three values are calculated using the Secchi disk depth, total phosphorus concentration, and chlorophyll measurement to obtain an average TSI. Those lakes with relatively low TSI values are unproductive and termed oligotrophic. Those lakes with very high TSI values are classified as productive (eutrophic). Those lakes with TSI values falling in between are considered mesotrophic.

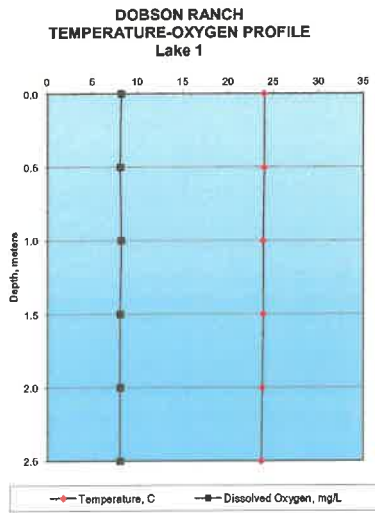
DOBSON RANCH LAKE 1

The Lake 1 temperature ranged from a low of 24.0 C to a high of 24.8 C (75-77 F). The lake exhibited no thermal stratification (vertically mixed) and no significant loss of oxygen with depth. Water pH was 8.2 SU indicating low to moderate algae density. Dissolved oxygen (7.2-8.0 mg/L) was satisfactory for the fishery and fish activity appeared normal. Increases in dissolved oxygen concentration frequently occur during winter because of reduced respiration and decomposition rates at colder temperatures and the ability of cold water to hold more dissolved oxygen than warm water. Transparency was 1.45 m and turbidity ranged from 3.7 to 4.4 NTU. Fountains were in service.

Depth, m	Temp, C	Oxygen, mg/L
0.0	24.0	8.2
0.5	24.0	8.1
1.0	23.9	8.2
1.5	23.9	8.1
2.0	23.8	8.1
2.5	23.7	8.1

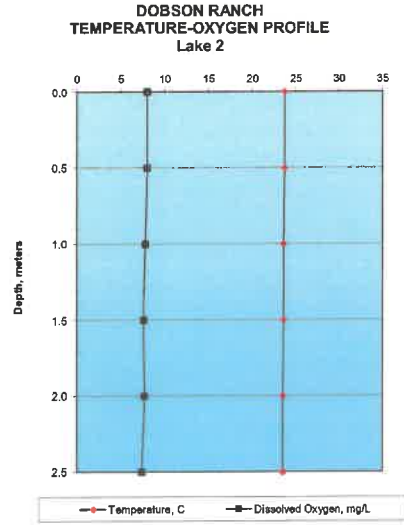
DOBSON RANCH LAKE 2

Water temperature ranged from 23.7-24.5 C (75-76 F). Lake 2 was vertically mixed. No substantial loss of oxygen in the deep waters occurred (see attached profiles). The surface dissolved oxygen concentrations (7.2-8.0 mg/L) were above the target 6.0 mg/L concentration desired to protect the fishery and no fish stress was observed. Fountains were in service. Water pH remained suitable at 7.2-8.2 SU, and indicated reduction in suspended (planktonic) algae density. Low pH is advantageous because it prevents conversion of ammonium ions (NH_4^+) to toxic (to aquatic animals) ammonia (NH_3) gas. Transparency (Secchi disk depth) decreased to 1.45 m (4.7 ft) and turbidity increased to 5.6-6.2 NTU; still representing reasonably clear waters.

Depth, m	Temp, C	Oxygen, mg/L
0.0	23.7	8.0
0.5	23.7	8.0
1.0	23.6	7.8
1.5	23.6	7.6
2.0	23.5	7.7
2.5	23.5	7.4

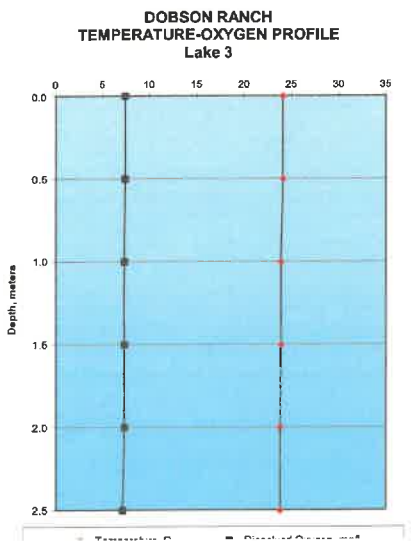
DOBSON RANCH LAKE 3

Lake temperature range was 24.1-24.5 C (75-76 F). Water pH was 8.2-8.7 SU. . Low pH is more advantageous because it prevents conversion of ammonium ions (NH_4^+) to toxic (to aquatic animals) ammonia (NH_3) gas. Lake 3 exhibited no thermal stratification (vertically mixed) and had no significant loss of oxygen in the deep waters (see attached profiles). The fountain was not in service. The surface dissolved oxygen concentration (7.4-8.7 mg/L) met the minimum target of 6.0 mg/L desired to protect the fishery. No fish stress was observed Transparency was stable at 1.65 m (5.5 ft). Turbidity range was 2.2-9.7 NTU. Fountains were not in service at the time of sampling.

Depth, m	Temp, C	Oxygen, mg/L
0.0	24.1	7.4
0.5	24.1	7.4
1.0	23.9	7.3
1.5	23.9	7.3
2.0	23.8	7.3
2.5	23.8	7.1

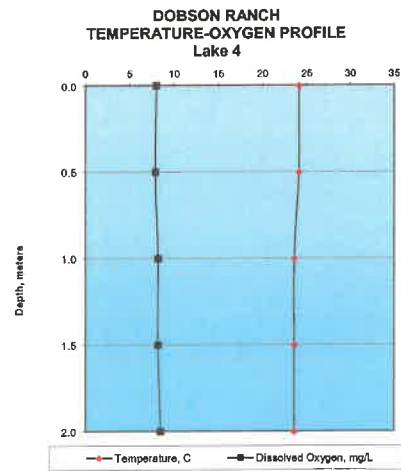
DOBSON RANCH LAKE 4

Lake 4 was vertically mixed with little loss of oxygen in the deep water (see attached profiles). Temperature ranged from 24.1 to 24.6 C (75-76 F). The surface dissolved oxygen concentrations were 8.0 to 8.1 mg/L. Concentrations were at the satisfactory level for the fishery and fish activity appeared normal. The fountain was in service. Water pH ranged from 8.3-8.6 SU and indicated a moderate suspended algae density. Water transparency was stable at 0.97 m (3.1 ft). Turbidity was slightly higher than typical at 11-19 NTU.

Depth, m	Temp, C	Oxygen, mg/L
0.0	24.1	8.0
0.5	24.1	7.9
1.0	23.6	8.2
1.5	23.6	8.2
2.0	23.6	8.5
