07 August 2025

Dobson Ranch HOA
2719 South Reyes
Mesa, Arizona 85202

July 2025 Lake Report

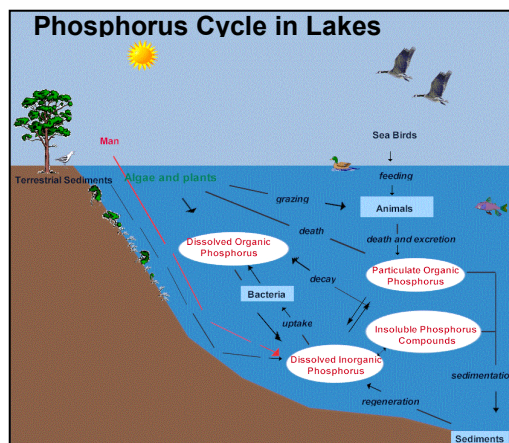
Algae are plants and require nitrogen and phosphorus for growth. In the desert southwest, large growths of planktonic algae typically form in the summer when total phosphorus concentrations are above 0.030 mg/L. Nitrogen values usually need to be at least 10 times that of phosphorus and in a soluble, usable (nitrate or ammonia) form to stimulate algae growth. Phosphorus and nitrogen cycles in the aquatic environment are illustrated below.

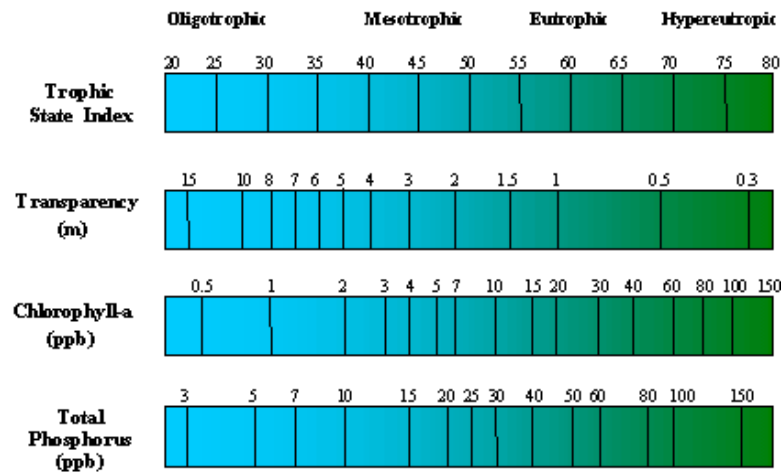
The Carlson Trophic Status Index (TSI) is a series of calculations that attempt to put a numerical value on water quality. The more algae and greener a lake is, the more nutrients a lake has, and the less transparent the water becomes, the higher the trophic status and the greater the TSI value. Three values are calculated using the Secchi disk depth, total phosphorus concentration, and chlorophyll measurement to obtain an average TSI. Those lakes with relatively low TSI values are unproductive and termed oligotrophic. Those lakes with very high TSI values are classified as productive (eutrophic). Those lakes with TSI values falling in between are considered mesotrophic.

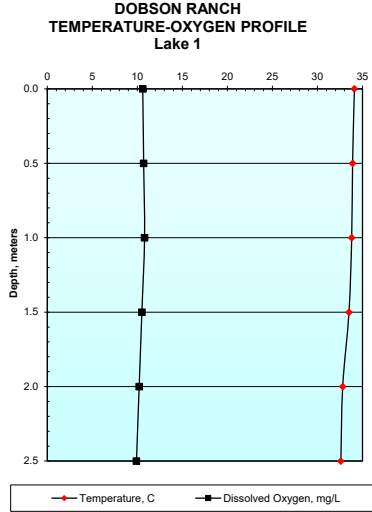
DOBSON RANCH LAKE 1

The Lake 1 temperature ranged from a low of 31.1 C to a high of 33.8C. The lake exhibited no thermal stratification (vertically mixed) and no significant loss of oxygen with depth. Water pH ranged between 8.2 and 8.5 SU indicating low to moderate algae density. Dissolved oxygen (6.8-10.8 mg/L) was satisfactory for the fishery and fish activity appeared normal. Decreases in dissolved oxygen concentration frequently occur during summer because of increased respiration and decomposition rates at warmer temperatures and the inability of warm water to hold more dissolved oxygen than cold water. Transparency was 0.8 m and turbidity was 6.6. Fountains were in service.

Depth, m	Temp, C	Oxygen, mg/L
0.0	34.1	10.6
0.5	33.9	10.7
1.0	33.8	10.8
1.5	33.5	10.5
2.0	32.8	10.2
2.5	32.6	9.9

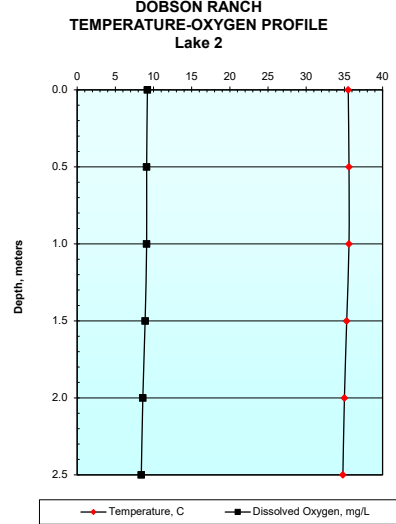
DOBSON RANCH LAKE 2

Water temperature ranged from 31.1-33.8 C. Lake 2 was vertically mixed. No substantial loss of oxygen in the deep waters occurred (see attached profiles). The surface dissolved oxygen concentrations (6.2-9.1 mg/L) were above the target 6.0 mg/L concentration desired to protect the fishery and no fish stress was observed. Fountains were in service. Water pH remained suitable at 8.2-8.5 SU, and indicated reduction in suspended (planktonic) algae density. Low pH is advantageous because it prevents conversion of ammonium ions (NH₄⁺) to toxic (to aquatic animals) ammonia (NH₃) gas. Transparency (Secchi disk depth) decreased to 1.40 m and turbidity increased to 5.7 NTU; still representing reasonably clear waters.

Depth, m	Temp, C	Oxygen, mg/L
0.0	35.5	9.2
0.5	35.6	9.1
1.0	35.6	9.1
1.5	35.3	8.9
2.0	35.0	8.6
2.5	34.8	8.4

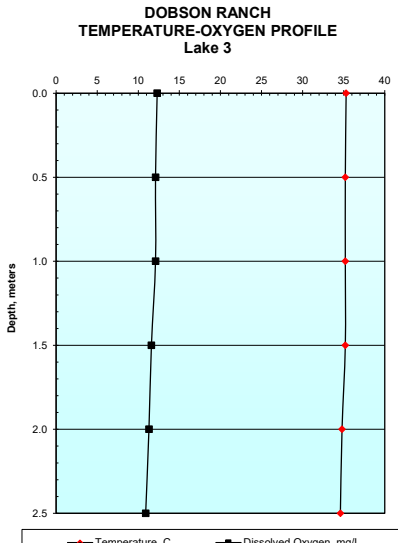
DOBSON RANCH LAKE 3

Lake temperature range was 30.9-35.2C. Water pH was 8.2-8.5 SU. Low pH is more advantageous because it prevents conversion of ammonium ions (NH_4^+) to toxic (to aquatic animals) ammonia (NH_3) gas. Lake 3 exhibited no thermal stratification (vertically mixed) and had no significant loss of oxygen in the deep waters (see attached profiles). The fountain was not in service. The surface dissolved oxygen concentration (5.6-12.1 mg/L) did not meet the minimum target of 6.0 mg/L desired to protect the fishery; however daily oxygen production by algae prevented fishery issues. No fish stress was observed. Transparency was stable at 1.42 m. Turbidity was 9.0 NTU. Fountains were not in service at the time of sampling.

Depth, m	Temp, C	Oxygen, mg/L
0.0	35.3	12.3
0.5	35.2	12.1
1.0	35.2	12.1
1.5	35.2	11.6
2.0	34.8	11.3
2.5	34.6	10.9

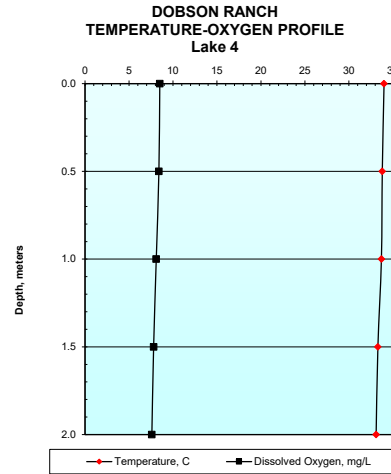
DOBSON RANCH LAKE 4

Lake 4 was vertically mixed with little loss of oxygen in the deep water (see attached profiles). Temperature ranged from 31.9 to 36.7 C. The surface dissolved oxygen concentrations were 8.1 to 8.3 mg/L. Concentrations were at the satisfactory level for the fishery and fish activity appeared normal. The fountain was in service. Water pH ranged from 8.2-8.3 SU and indicated a moderate suspended algae density. Water transparency was increased to 1.09 m. Turbidity was typical at 6.5 NTU.

Depth, m	Temp, C	Oxygen, mg/L
0.0	34.0	8.5
0.5	33.8	8.4
1.0	33.7	8.1
1.5	33.3	7.8
2.0	33.1	7.6
